## 2. Palmer Station (03/29/15 – 07/31/16)

This sections describes quality control of solar data recorded at Palmer Station between 03/29/15 and 07/31/16. This period resulted in a total of 20,431 solar scans. The system was inspected and serviced in March 2015 before the reporting period. On-site standards of spectral irradiance were compared with traveling standards during this visit. The system's performance was affected by several issues:

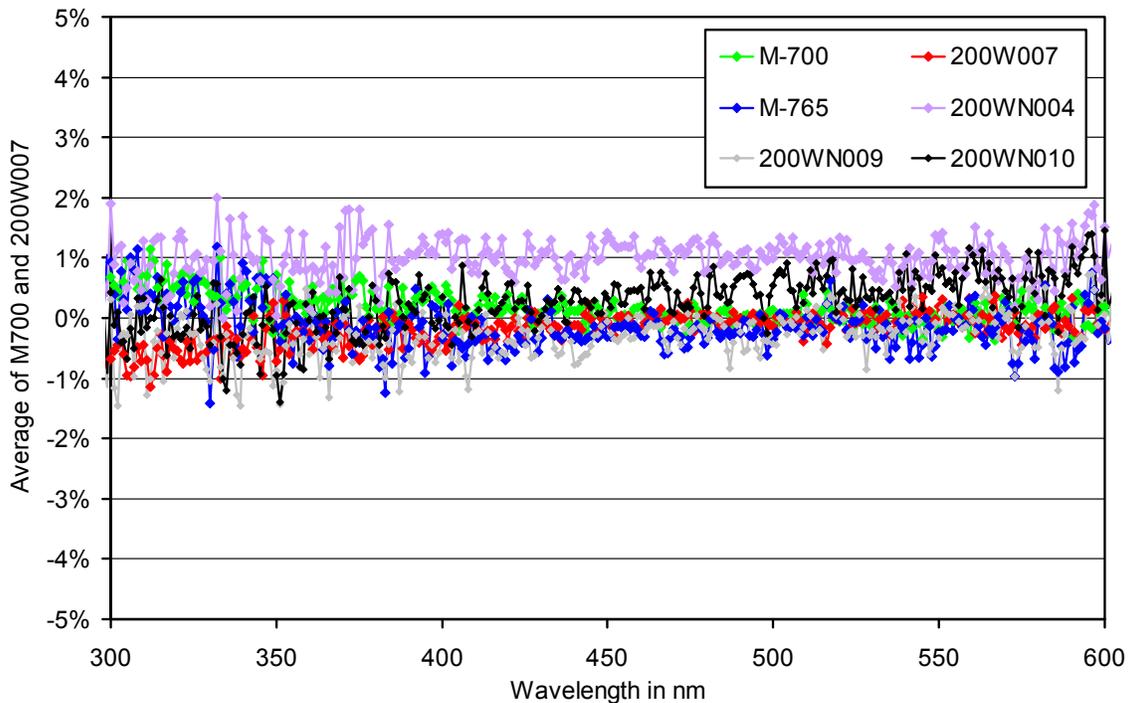
The five on-site standard and the traveling standard were compared during the March 2015 site visit. Figure 1 shows results for data collected at the end of the visit (“season opening scans”). Results are referenced against the average of measurements of on-site standards M700 and 200W007. The calibrated output of the five on-site standard agreed to within  $\pm 1.0\%$  with this reference. Results for the traveling standard 200WN004 are biased high by approximately 1%. This bias may be caused by the damage the lamp sustained during the visit. The excellent agreement between results for the “regular” on-site standards 200W007, M700 and M765 and the long-term standards 200WN009 and 200WN010 gives confidence in the scale of irradiance applied to solar data of the reporting period.

**Figure 1.** Comparison of the calibration of on-site standards M700, 200W007, M765, 200WN009, and 200WN010; and the traveling standard 200WN004 on 3/28/2015. Data are reference to the average of the measurements of lamps M700 and 200W007.

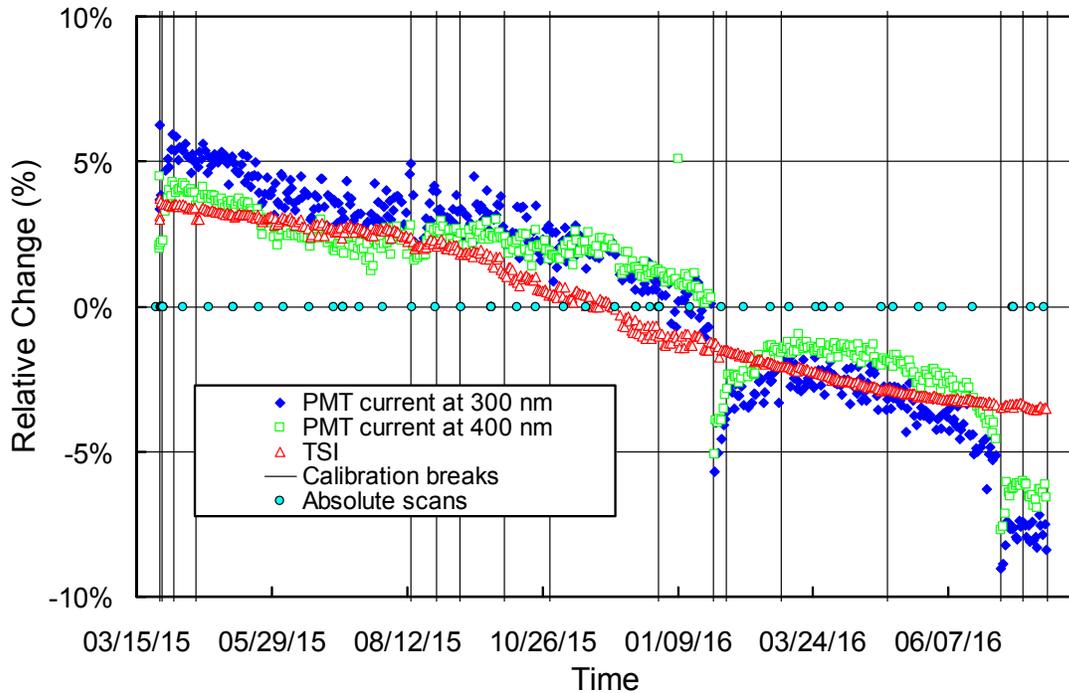
Figure 2 shows changes in TSI readings and PMT currents at 300 and 400 nm, derived from response scans performed between 3/27/15 and 7/31/16. During this time, the output of the internal lamp decreased monotonically by 7% as indicated by the TSI sensor. (A new internal “response” lamp was installed during the site visit. A drift of this magnitude is not unusual for a new lamp). The PMT currents decreased by a similar amount, reflecting the change of the lamp. There are two discontinuities. The first one was on 1/29/16 and coincides with the installation of the back-up lamp power supply. The second discontinuity occurred on 7/6/16 and its cause is unknown. The calibration of the system was changed at the times of these discontinuities (vertical lines in Figure 2).

**Figure 2.** Time-series of PMT current at 300 and 400 nm, and TSI signal. All data were extracted from measurements of the internal irradiance standard and are normalized to their average. Calibration break points (Table 1) and times of absolute scans are also indicated.

Changes in the system’s sensitivity were corrected by adjusting calibration break points accordingly. The reporting period was divided into sixteen calibration periods, labeled P1 – P15 (Table 1). Figure 3 shows ratios of the calibration functions applied during Periods P2 through P12 relative to the function of Period P1.

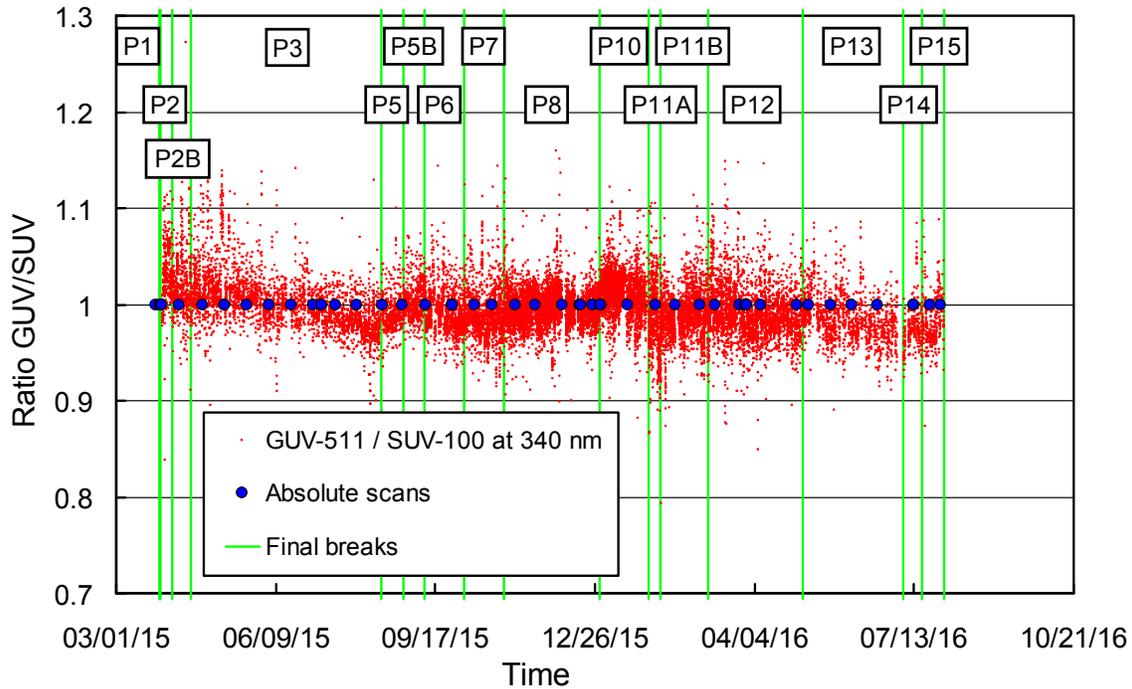
The suitability of the selected calibration break points was checked by comparing calibrated SUV-100 measurements with GUV data. Figure 4 shows the ratio of GUV-511 data (340 nm channel) and final SUV-100 measurements, which were weighted with the spectral response function of this channel. The ratio is normalized and should ideally be one. The graph indicates that GUV and SUV measurements are consistent to within  $\pm 2.7\%$  ( $\pm 1\sigma$ ). There are no step changes exceeding 1.0% between calibration periods.

These results indicate that solar data of the SUV-100 have been appropriately corrected. Remaining uncertainty caused by step changes in sensitivity are below 1% for all periods. The figure also indicates that all data affected by the malfunctioning shutter have been removed.

Figure 5 shows a few short periods when the ratio is abnormally high (e.g., on 5/7/15, 10/16/15, 1/11/16, and 3/9/16) when snow was presumably covering the diffuser of the SUV-100 spectroradiometer for short periods. GU measurements are less affected by snow because the instrument is heated to a higher temperature.

**Figure 4.** Ratio of GUV-511 measurements at 340 nm with final SUV-100 measurements. The latter were weighted with the spectral response function of the GUV-511 340 nm channel.
