## 2. Palmer Station (03/29/15 – 07/31/16)

This sections describes quality control of solar data recorded at Palmer Station between 03/29/15 and 07/31/16. This period resulted in a total of 20,431 solar scans. The system was inspected and serviced in March 2015 before the reporting period. On-site standards of spectral irradiance were compared with traveling standards during this visit. The system's performance was affected by several issues:

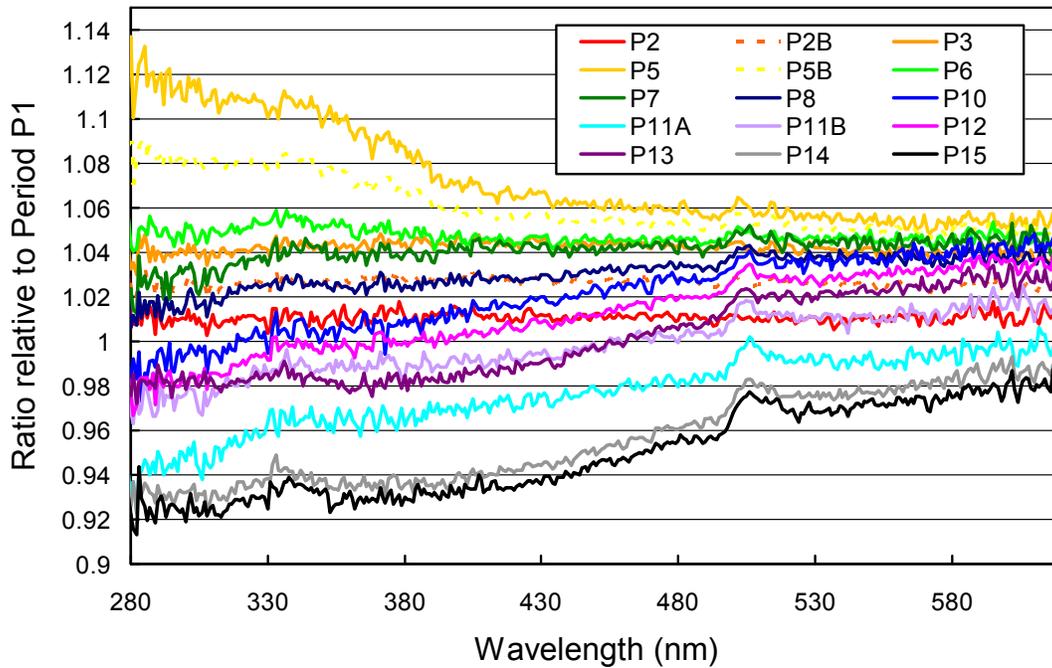
Changes in the system’s sensitivity were corrected by adjusting calibration break points accordingly. The reporting period was divided into sixteen calibration periods, labeled P1 – P15 (Table 1). Figure 3 shows ratios of the calibration functions applied during Periods P2 through P12 relative to the function of Period P1.

**Figure 3.** Ratios of spectral irradiance assigned to the internal reference lamp for periods P2 – P15 relative to Period P1. Broken lines indicate interpolated data.

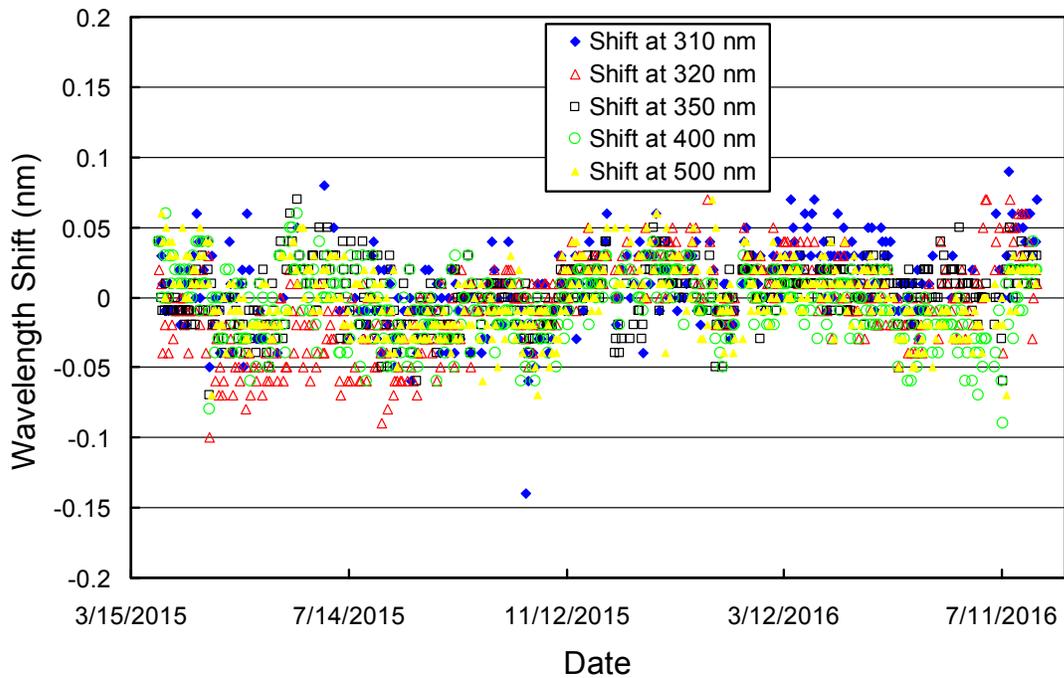
Figure 6. Wavelength accuracy check of the final Version 0 data at five wavelengths by means of Fraunhofer-line correlation. Noon-time measurements from every day of the year have been evaluated.

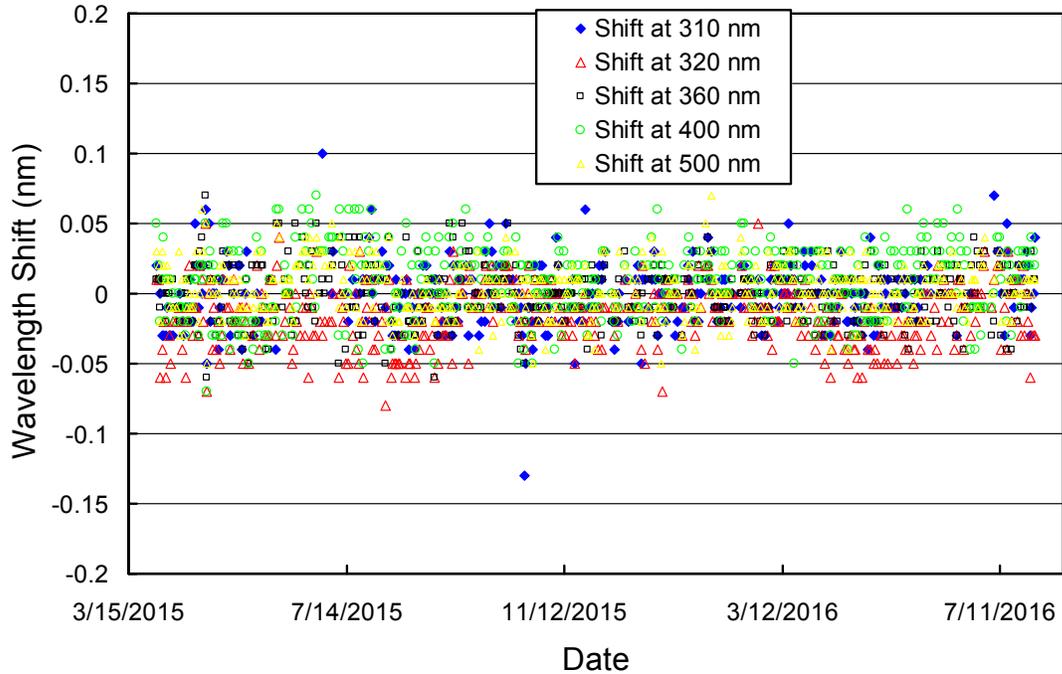
Wavelength stability of the system was monitored with the internal mercury lamp. Information from the daily wavelength scans was used to homogenize the data set by correcting day-to-day fluctuations in the wavelength offset. The wavelength-dependent bias of this homogenized dataset and the correct wavelength scale was determined with the Version 2 Fraunhofer-line correlation method (Bernhard et al., 2004). Figure 5 shows the correction function calculated with this algorithm. Figure 6 indicates the wavelength accuracy of final Version 0 data for five wavelengths in the UV and visible by running the Version 2 Fraunhofer-line correlation method a second time. Shifts are typically smaller than  $\pm 0.1$  nm. (The standard deviations for wavelengths between 305 and 400 nm are 0.029 nm on average). The wavelength accuracy was further improved as part of the production of Version 2 data. Figure 7 shows the wavelength accuracy of Version 2 data. The standard deviations for wavelengths between 305 and 400 nm decreased to 0.024 nm.

Figure 7. Same as Figure 6 but for Version 2 data.
