BREWER MKIV SPECTROPHOTOMETER

SERVICE MANUAL

MM-BA-C230/B REV -, Dec.8, 1999

SCI-TEC Instruments Inc.

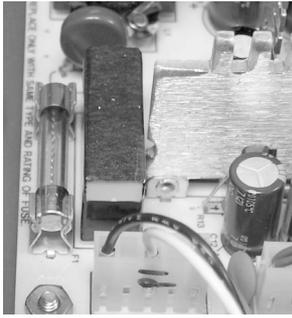
If the cover is not warm, then perhaps the Power Switch is defective, or a fuse requires replacement. With power disconnected, use an

Ohmmeter to confirm that the Switch is functional, and check the two fuses next to the power supply cover as indicated in the photograph. If a fuse needs changing, ensure that AC power is disconnected, and replace the fuse with the appropriate spare.

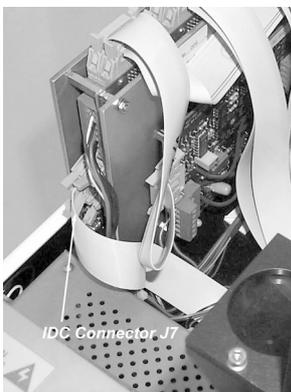
Reconnect the communication cable to the tracker and disconnect the communications cable at the Brewer. Short pins C-B and then pins I-J and test as in step 4. If the test passes, reconnect the cable to the Brewer and open the cover of the Brewer. Turn the power off and disconnect the IDC connector (the IDC connector, J7, is the connector attached to the shielded ribbon cable shown in the picture to the left) Use a small wire jumper to connect pins 2-8, and then pins 4-6, using the echo-back test each time. (The IDC pins begin from 1 at the triangle stamped on the side of the connector and increment in odd numbers on the same row - 1, 3, 5, 7, 9 on the first row and 2, 4, 6, 8, 10 on the next row, in the same direction). If the test fails at any point of this cable test procedure the faulty connection should be repaired before proceeding to the next test. If all of these procedures have positive results, then the

problem lies in the Brewer Main Electronics Board. Reconnect all the cabling to the instrument and continue to the next test.

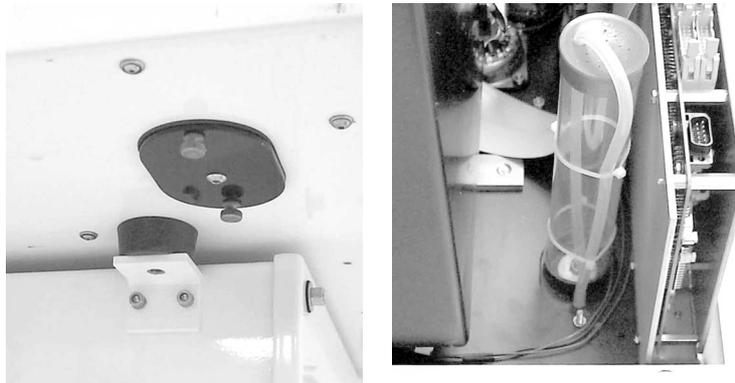
The breather desiccant cartridge allows the Brewer to compensate for normal pressure changes, while preventing the influx of moist air. Breather desiccant is housed in a plastic container with a breathing tube placed at the bottom of the cartridge. The other end of the tube is connected to a port at the bottom on the underside of the Brewer and is exposed to the outside air. As the air is drawn in from the outside, the air is dried as it passes the desiccant. Reference figure 10.8. Note that the breather desiccant does not remove moisture from the Brewer. Extra desiccant is needed to remove moisture from inside the instrument.
